## EPC Industry

### CASE STUDY

Category Failure Investigation of Front Waterwall Swage Tube

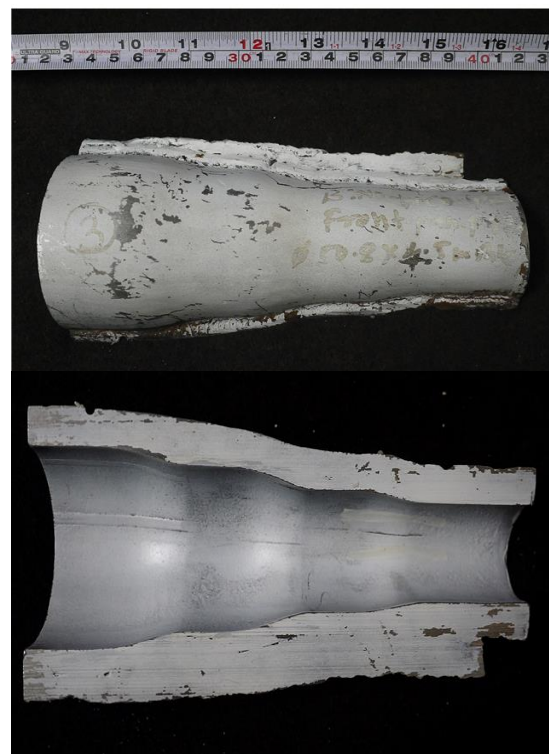
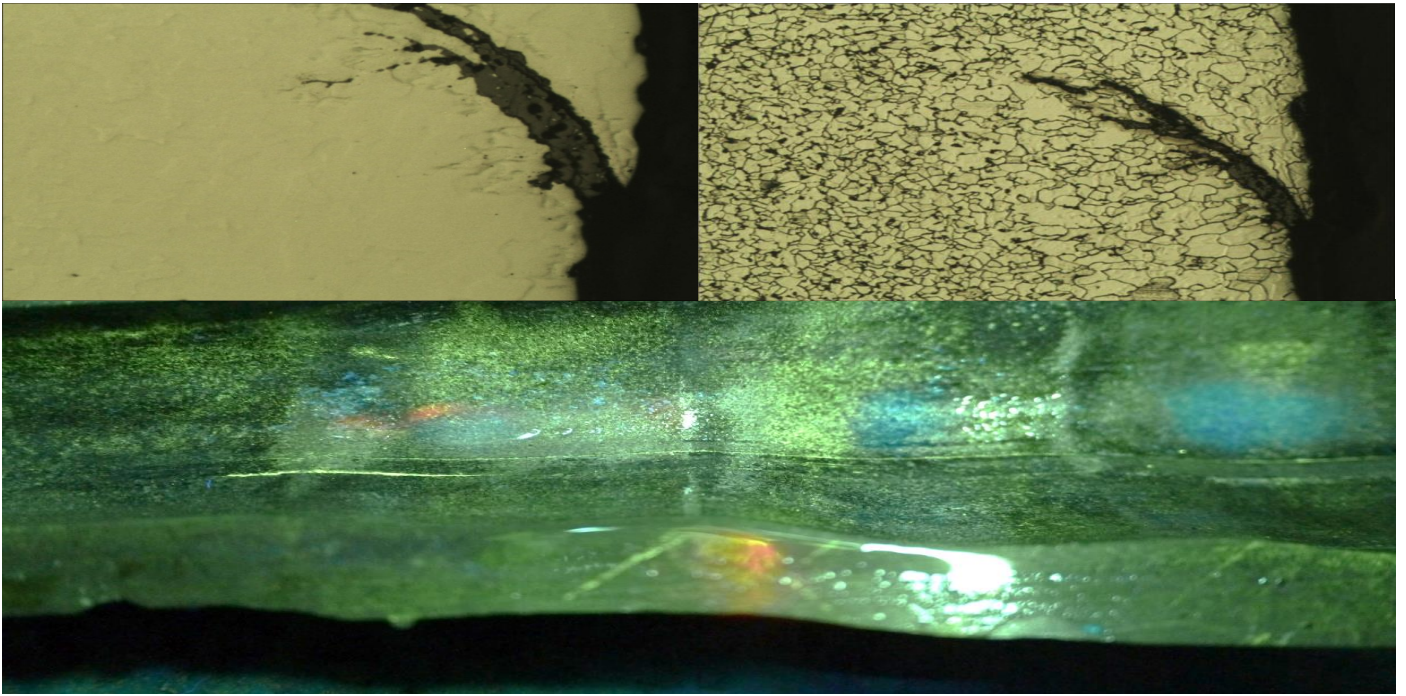
- Front water wall panel tube no. 34 from LHS side, failed in form of leakage during first hydro test after boiler erection.
- The failure was noticed at one location of tube in the particular lot from swaging area.
- The end portion has undergone three stage swaging operation that reduces the diameter of the tube to fix it within the weldolet.

- The leakage during hydro test is because of the scale entrapment occurred possibly during upset of manufacturing process parameters that has aggravated during swaging operation.

- The tube metallurgy appears to be satisfactory in terms of MOC, microstructure and hardness values.
- Scale entrapment from ID surface is seen that appears to have formed during manufacturing stage and indicating hot work flaw.
