## Fabrication Industry

### CASE STUDY

Category Investigation of Top Dished End

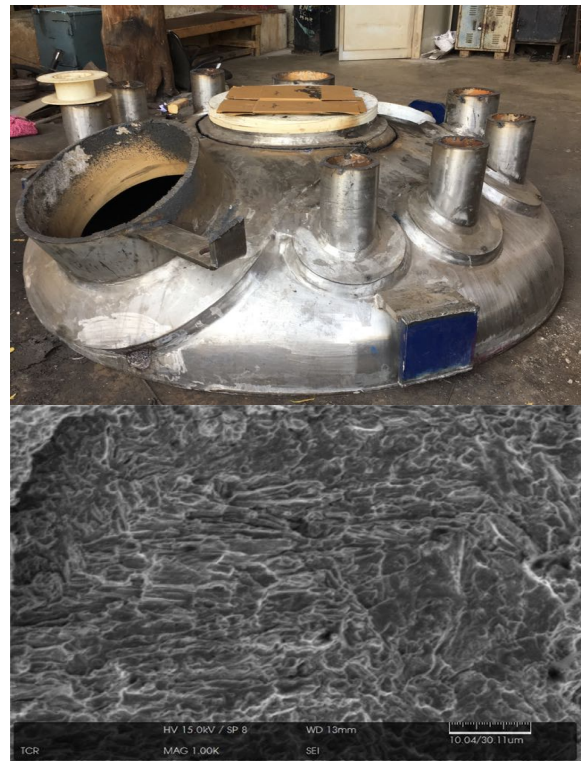
- Duplex stainless-steel top dish end#180249 of the pressure vessel was found to develop crack during hydro test.
- Initially 40- and 20-mm thick plate material was received for equipment. Top and bottom dished ends were welded with 2 long seams under approved PQR without solution annealing.
- The welds were found internally sound by hot pressing. Wrinkles were noticed in bottom dish near long seam. But it cracked during cold pressing when repair was attempted.

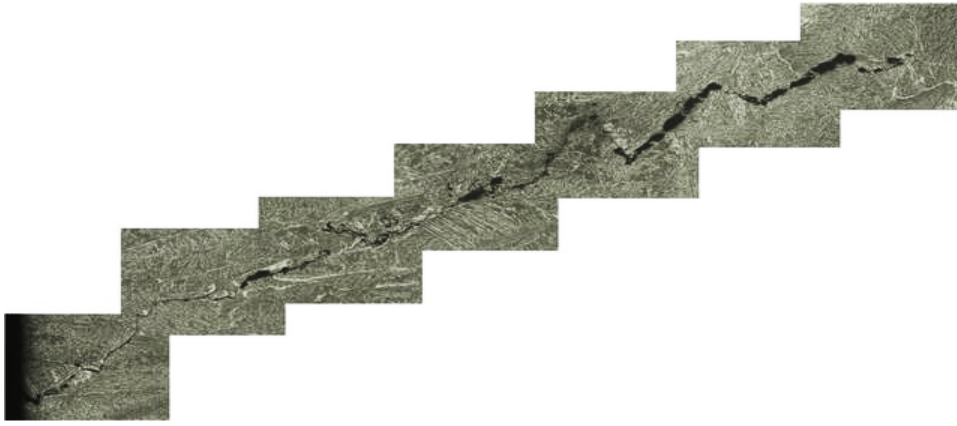
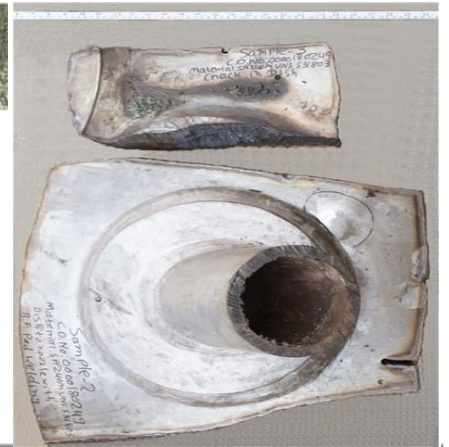
- The dish end failure from the weld joint is because of the high level hydrogen introduced during the welding.
- The hydrogen into the subject weld joint is found to be 38 ppm and is considered to be very high.

- The metallurgical condition of parent metal and all the weld joints is found to be normal. The only exception is the long seam weld joint whose impact values at -40°C are lower.
- Crack initiation is in brittle mode occurring into the long seam weld joint on dish end.
- The reasons for hydrogen build up in long seam weld joint on dish end requires to be looked into based on welding process parameters and consumables used.
- Similar welding done on other components needs evaluation and concern.
