# Fertilizer Industry

## CASE STUDY

Category Investigation of Cracking Behaviour of Ammonia Storage Tank

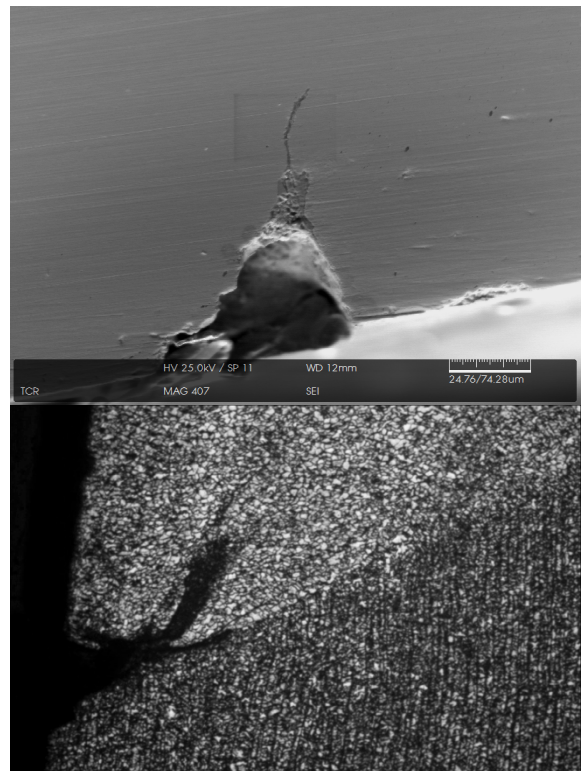
- A double wall double integrity, 10000MT, atmospheric pressure, Ammonia storage Tank displayed several cracks during inspection.
- Liquid ammonia is stored at  $-33^{\circ}\text{C}$ . The tank is made from SA537-Class I plates

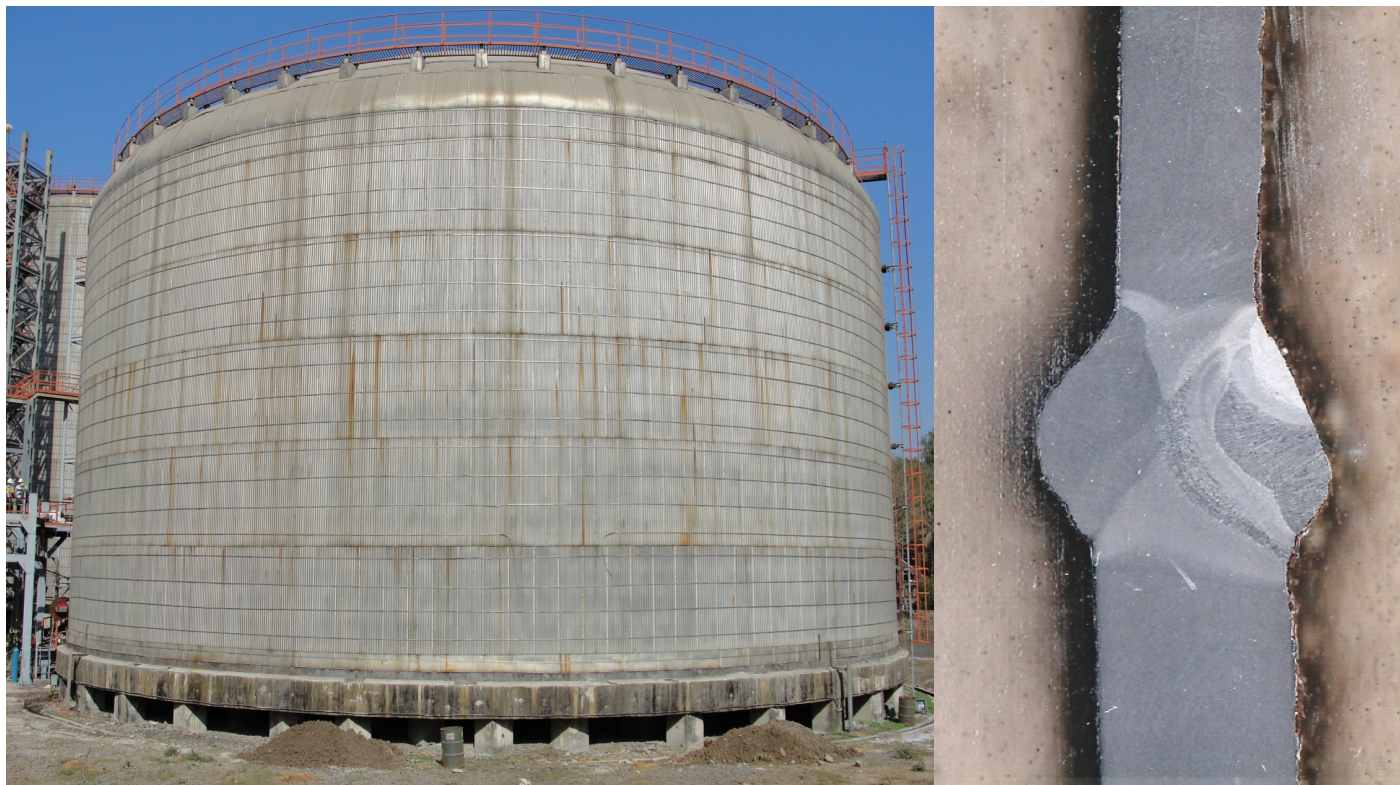
- From the investigation, it is established that minor weld defect like undercut have been identified as crack at weld/HAZ and a minor crack is observed to have propagated from the weld defect due to pressure fluctuation in the tank.
- The other crack observed on the parent metal approximately 60mm away from weld of the ammonia storage tank is due to SCC, which could be due to presence of clut. It has resulted over a prolonged years of ammonia storage in presence of oxygen impurities.

- Periodic monitoring of oxygen and moisture may be done from ammonia tank. The oxygen content should be kept below 0.05ppm. This may be achieved with process control and checking on imported ammonia as well.
  - Proper commissioning and decommissioning procedure may be followed to avoid presence of oxygen and to mitigate the risk of SCC damage at that time.
  - To get the best benefit of the present inspection opportunity RBI of tank is highly recommended in a near future that will ensure the safe and reliable operation of Ammonia tank. It will also improve the operation and inspection knowledge that will help to mitigate the risk of tank damage.
  - It is recommended to carry out fracture mechanics calculation for "Leak before break" or "break before leak" to put operational limits for safe operation of tank in view of present repairing done to the tank.
-
