# Insurance Industry

## CASE STUDY

| Category | Investigation of Jacket Pipe-Polymer Line |

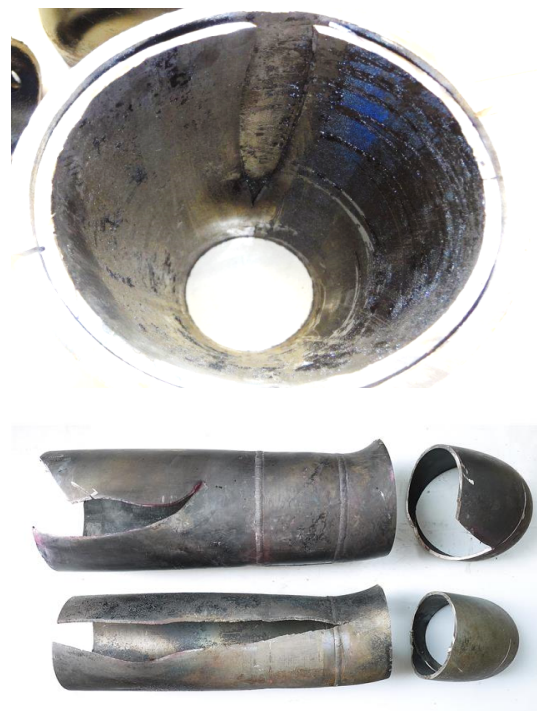
- The jacketed line connecting to extruder in polycarbonate plant was ruptured approximately 1 meter long in longitudinal direction.
- The failure was noticed as the extruder tripped all of a sudden due to high discharge pressure alarm.
- The failure had taken place twice at spool number 4

- Failure pattern in both the cases appear similar;
- Stricter quality assurance with respect to material used, chemical composition & physical properties is necessary, ensuring the original stress analysis of jacketed piping meeting worst combination of temperature variation and cyclic variations which are possible during actual operation.
- It is necessary that the pipe should undergo proper solution heat treatment after cold working so as to confirm freedom from residual stresses. That can be ensured by microstructure as well as accepting the hardness in the range of  $180 \text{ BHN} \pm 20 \text{ BHN}$  as an indirect check on residual stresses.
- The reasons for sudden temperature drop in the oil need to be investigated.

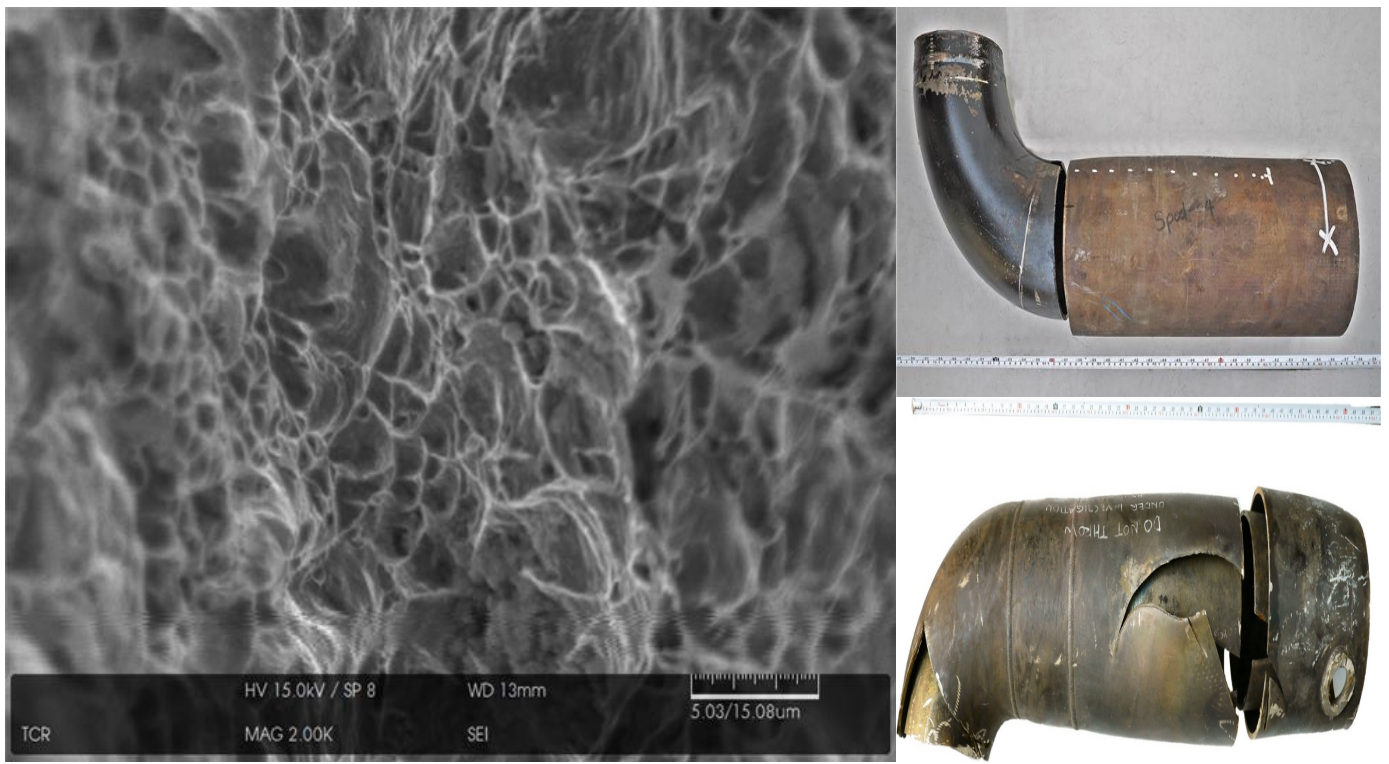
- The failure of the inner pipe of polymer extruder from spool , in both the cases is due to combined influence of presence of residual stress, internal pressure and probable thermal shock along with use of SS316-L material instead of SS316.
