## Power Industry

### CASE STUDY

Category Investigation of Front Waterwall Tube of Supercritical Boiler

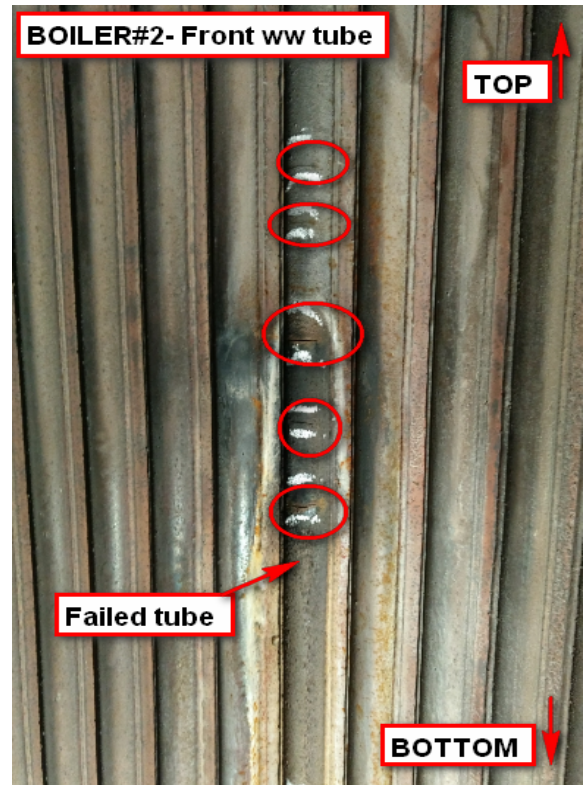
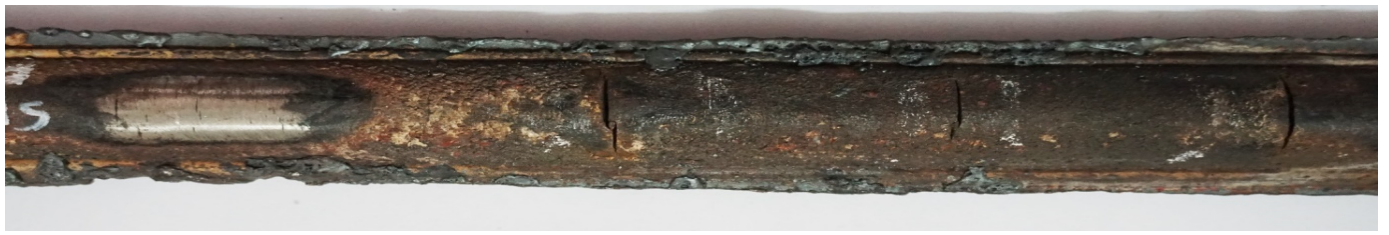
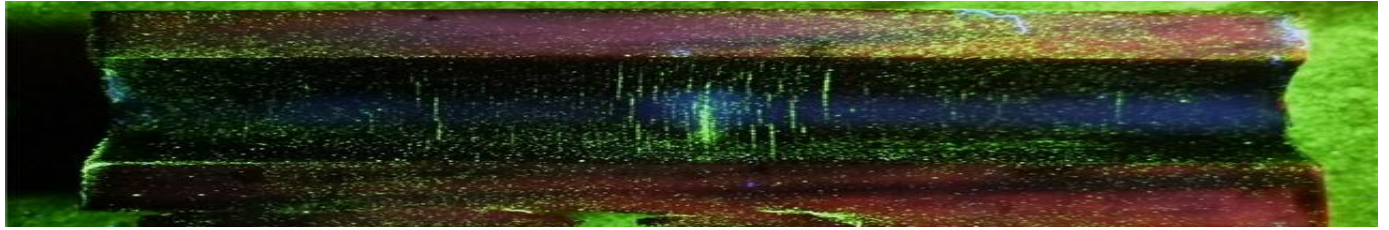
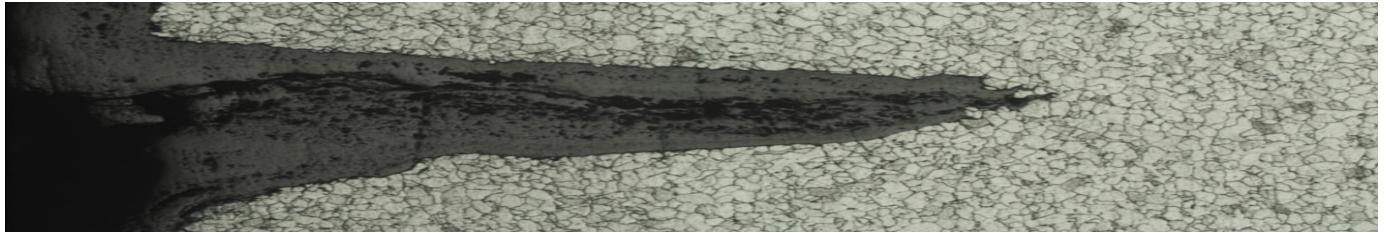
- Front waterwall vertical tube failed by leakage during hydrotest. The location of failure is about 64 meters from the ground level. The service life of tube is 16,918 hours.
- MOC of tube is as per SA 213 grade T12

- The front waterwall tube failure is because of thermal fatigue mode of through and through cracking.

- While MOC of tube conforms to the stipulated requirement, microstructure and mechanical properties indicate service degradation.
- The crack initiation from multiple locations is from both OD and ID. The crack morphology is transgranular with wide opening at initiation and blunt tips.
- Microstructural degradation indicates persistent and wide temperature fluctuations over a range.
- The possibility of secondary burning taking place in the subject region of tube failure that cause wide temperature fluctuations and temperature rise needs to be studied by process design expert.
- If the damage is limited to only one tube, then possibility of throttled flow in this particular tube maybe responsible for temperature fluctuations. Detailed internal examination with videoscopy may be done during next opportunity to the connecting header and tubing to find out any obstacle to the flow.
