# **Root cause Failure Investigation and Remaining life assessment of Reformer tubes**

Paresh Haribhakti and V K Bafna  
TCR Advanced Engineering Pvt. Ltd.,  
Vadodara and Mumbai

Presented at MICMAP 2009

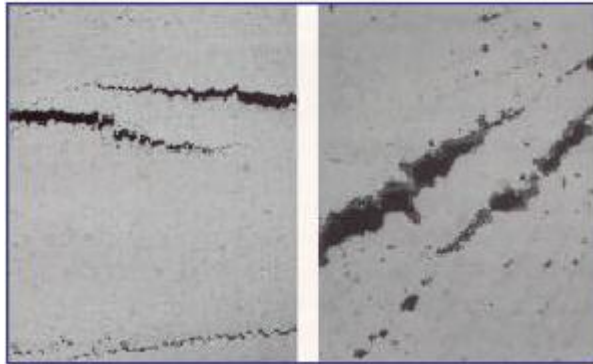
Micrograph of 0.4m test coupon sections  
(Magnification: x 50 / 200)

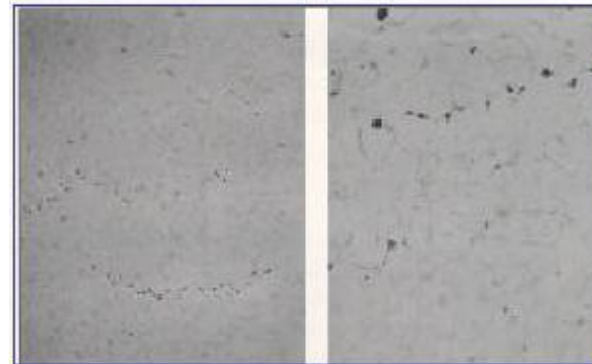
Micrograph of 1m test coupon sections  
(Magnification: x 50 / 200)

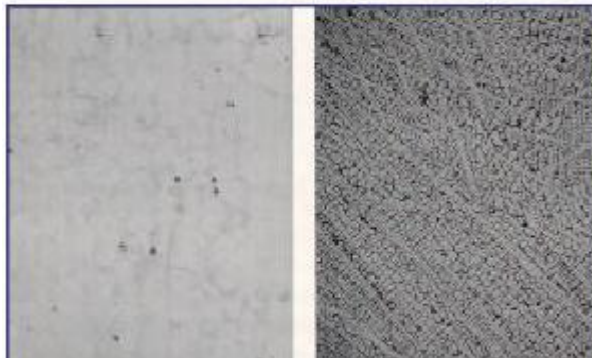
Micrograph of 7m test coupon sections  
(Magnification: x 50 / 200)

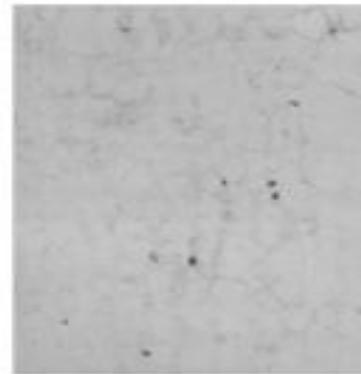
Class 2 (1% Creep Strain)

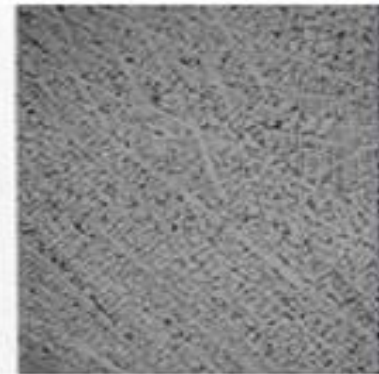
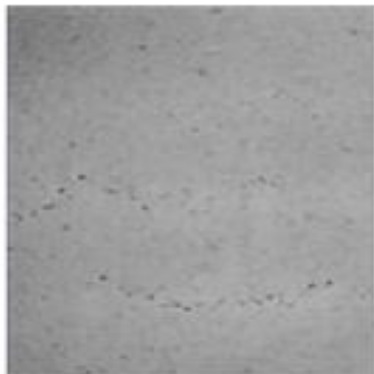
Class 3 (~3% Creep Strain)

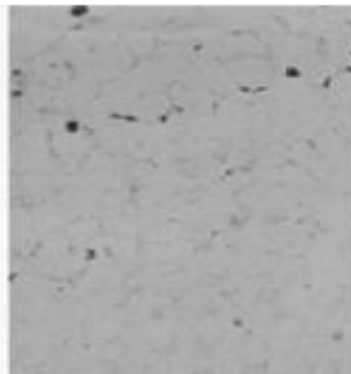
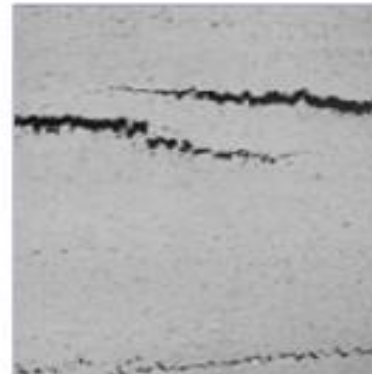
Class 4 & 5 (~5 to 7% Creep Strain)

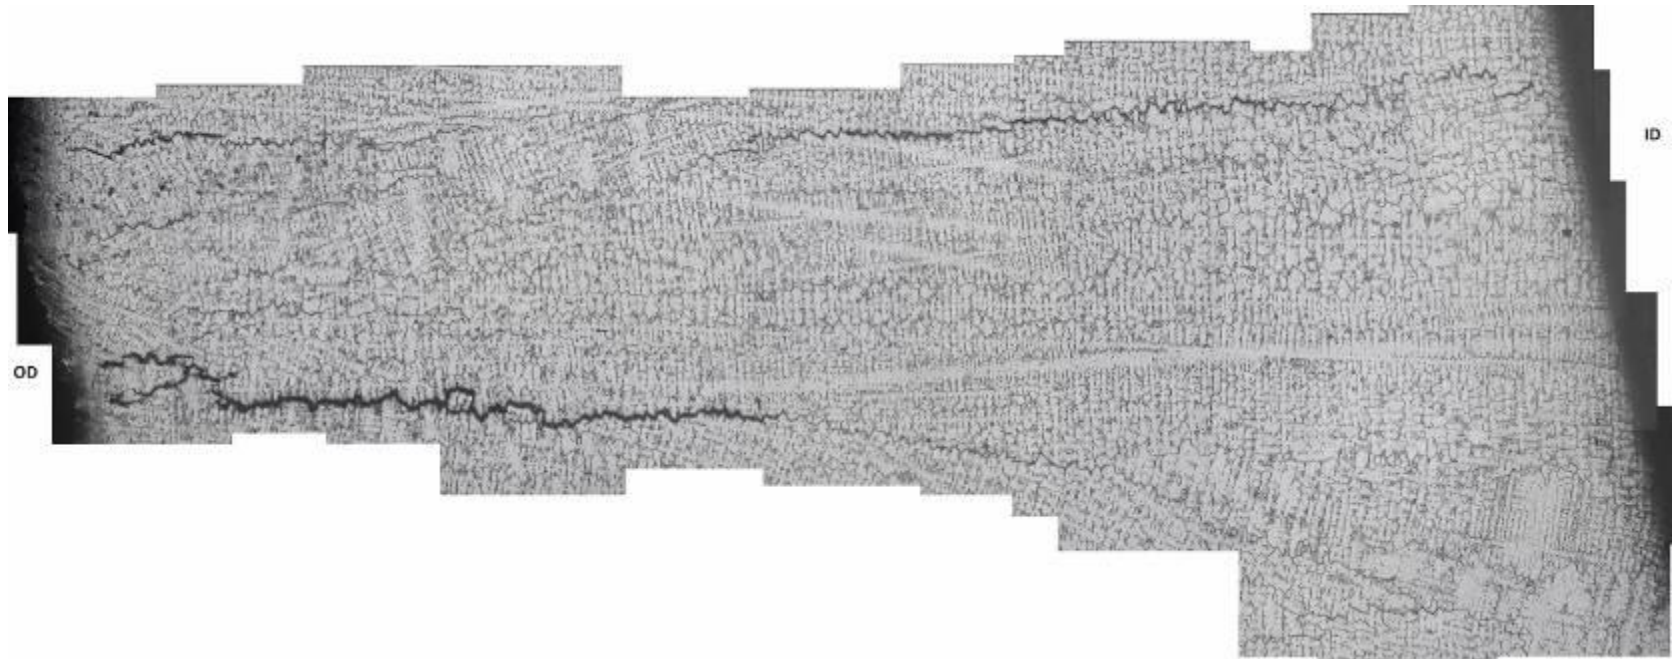
# Panoramic view of crack at OD to ID
