# Petrochemical Industry

## CASE STUDY

Category Investigation of Pass 4 Primary Quench Exchanger Process

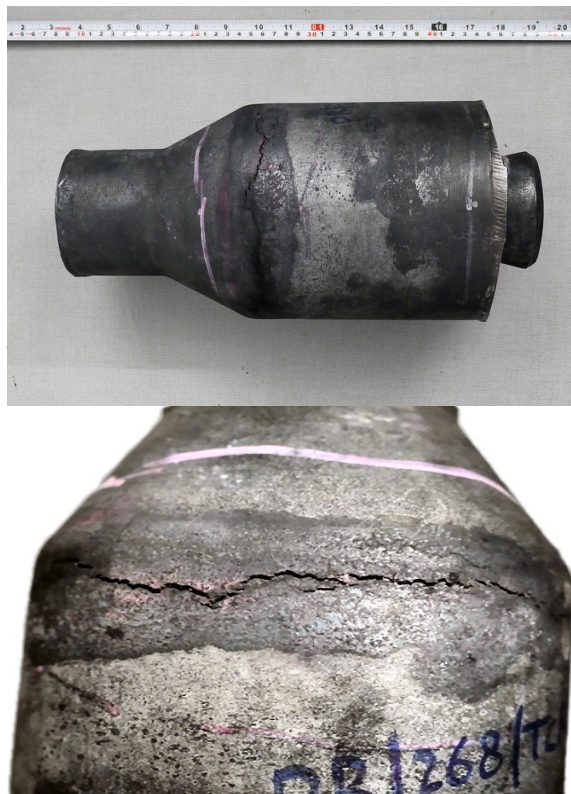
- The process gas inlet cast piece of Primary Quench Exchanger failed after 04 years of operation.
- High temperature process gas from pyrolysis furnace, exchanges the heat to generate steam in the quench exchanger.
- The material of construction for the PQE inlet casting is HP Modified grade alloy containing 35Ni and 25Cr.

- The length of the inner portion of the tube in inlet casting shall be strictly maintained as per upper tolerances as shown in the drawing; no oversize is permitted as it restricts free expansion.
- It is essential that dimensions to be checked to ensure the length as per the drawing, before welding.
- OEM may be consulted for possible alteration in tolerances /design modification in case when strict quality control cannot be ascertained.

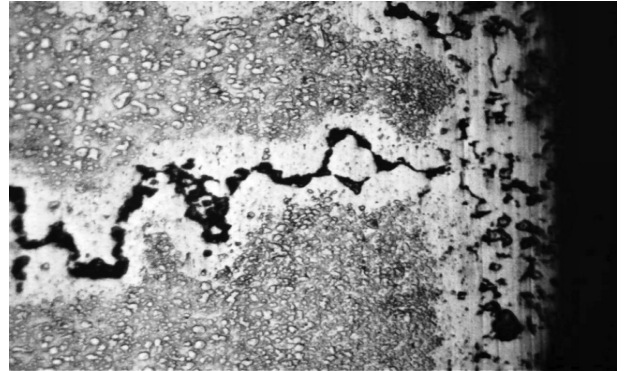
- The premature failure of inlet casting of primary quench exchanger appears to be under influence due to restriction in the inner tubular portion's thermal expansion that exerted tensile stresses at failed region and eventually failed under stress rupture mode.
