# Insurance Industry

## CASE STUDY

| Category | Investigation of Fire Damage<br>Assessment of Dryer |

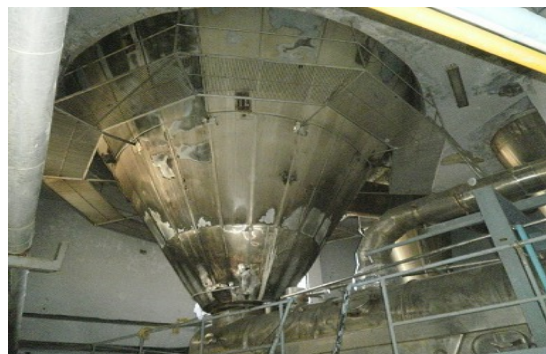
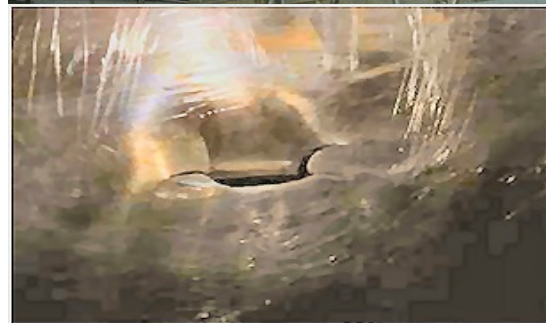
- Fire broke out in drying chamber and vibrofludiser started spreading towards cyclones and air exhaust system

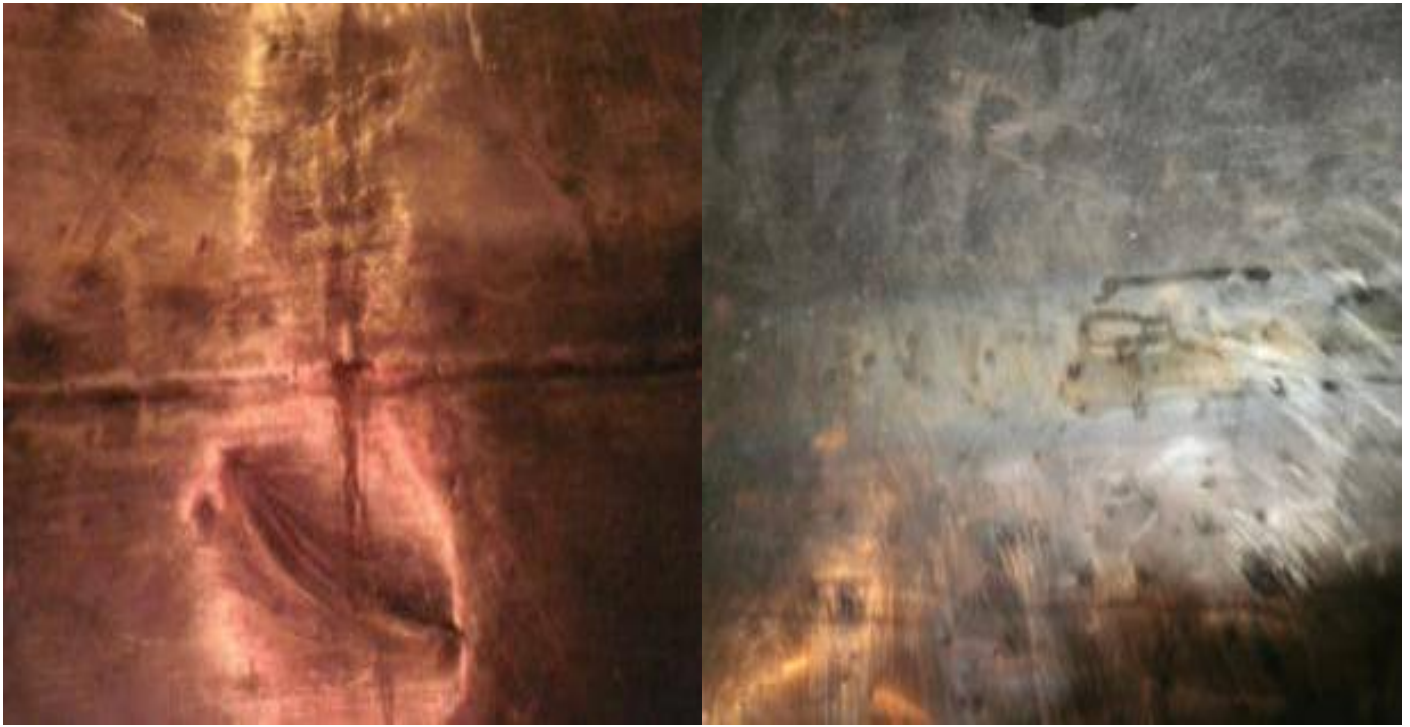
- Based on various NDT and assessment the dryer indicates exposure to temperature in the range of 400°C to 800°C at localized regions and that has caused carbide precipitation at the grain boundaries of SS 304 material. Such microstructural condition would made the dryer vulnerable to IGC (inter-granular corrosion) and IGSCC (inter granular stress corrosion cracking) attack which lead to leakages and localized cracking during operation and maintenance activities.

- Weld joints at top cover shows cracks due to thermal stresses from uncontrolled heating/ cooling during fire incident. However mechanical properties of the sheet metal do not seems to be affected as microstructure did not indicate grain coarsening. The exact effect of mechanical integrity may be established by cutting a sample from the dryer and subjected for mechanical testing.
